超声波换能器

(Ultrasonic Transducer)

HNC-8AS-2040Y

产品性能规格书

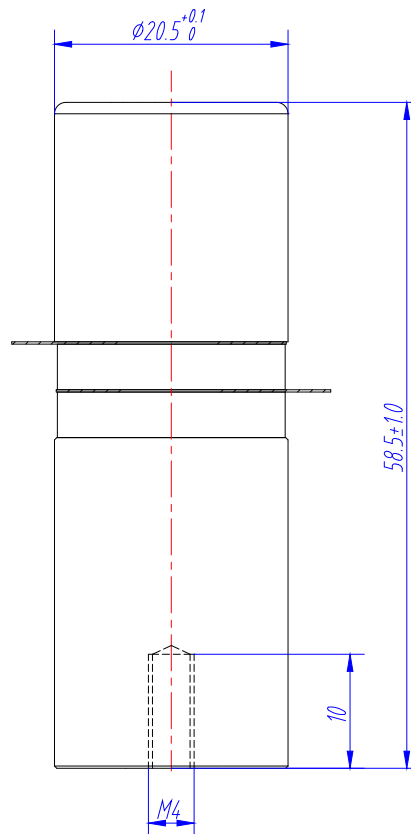
9.外形示意图（Drawings and Dimension）

详见产品外形图 As per the drawing No: HNC-8AS-2040Y

7. 组成材料 Materials

7.1 前辐射块 Front Matching: 铝合金 (Aluminum Alloy)

7.2 后匹配块 Back Matching : 铝合金 (Aluminum Alloy)

7.3 压电晶体 Piezo-ceramic: PZT-8(PZT-8)

7.4 电极片(Electrode): 铜合金 (Copper Alloy)
